Fire and explosions of tanker lorries

3 April 2016

Bassens (Gironde)

Explosion / BLEVE
 Mobile storage
 Liquefied gas
 Dangerous goods transportation

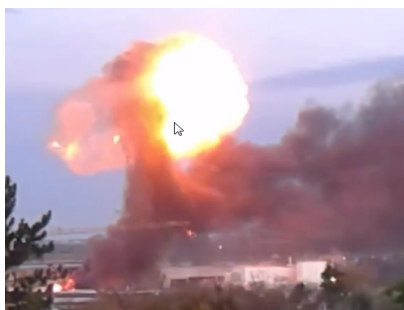
Extracted from an amateur video
